Special Report 79-27

# EXTENDING THE USEFUL LIFE OF DYE-2 TO 1986

## PART I: PRELIMINARY FINDINGS AND RECOMMENDATIONS

Wayne Tobiasson, Charles Korhonen and Robert Redfield

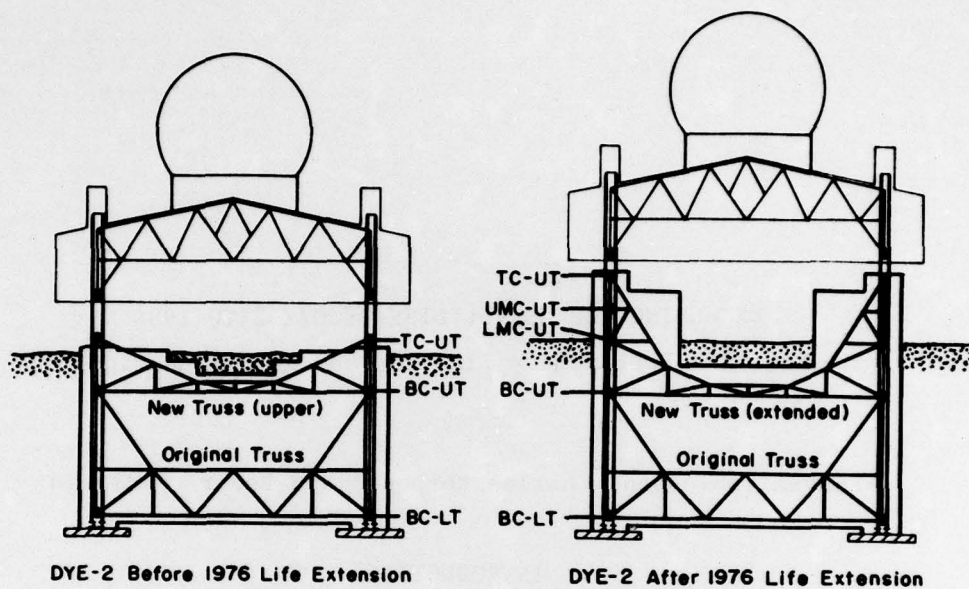
Figure 1. Elevation views of DYE-2 before and after the 1976 life extension.

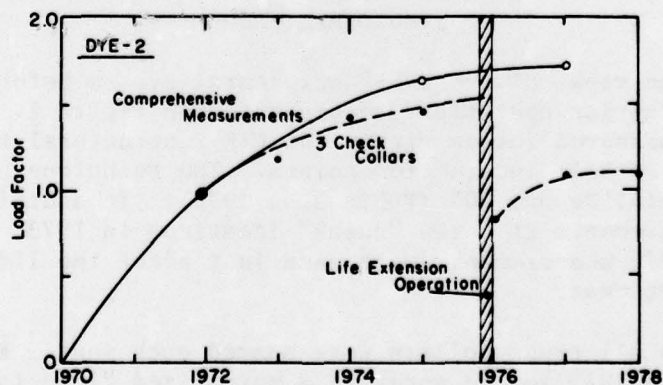
Figure 2. Load factor vs time for both comprehensive sway bolt measurements and measurements at three check collars. The check collars are defined in Table I.

The significant drop in the load factor shown in Figure 2 for the three check collars after the 1976 life extension operation is of interest. All readings taken of those collars are summarized in Table I. That information indicates that loads in those three collars were altered significantly by the life extension operation.

Since the comprehensive measurements in 1977 (Fig. 2) did not show a post-life-extension decrease, it is evident that the loads lost by the three check collars during the life extension operation were gained by other collars.

We recommend a comprehensive sway bolt measurement program at DYE-2 for the summer of 1979. Results from that program should allow us to better estimate the current rate of secondary stress accumulation in the structural frame. If those measurements indicate that the rate of stress increase is slight, it may be possible to continue with the existing structural system to 1986.

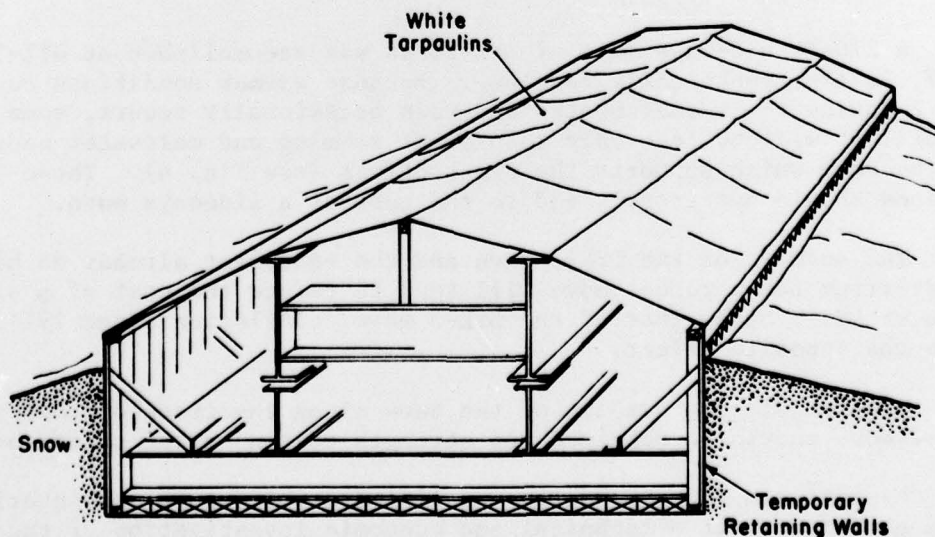
One important difference exists at DYE-2 that should be considered if a sideways move is contemplated. In the summer it can get very warm at DYE-2. That warmth could cause the snow that supports the new footings

to consolidate faster than at DYE-3. Also, there have been occasions of heavy rain at DYE-2 during the summer months. With the snow surface configured as it was at DYE-3 during the move, this rain could drain alongside the footings and perhaps undermine them. Therefore we feel it would be necessary at DYE-2 to erect 8 to 12-ft high temporary plywood retaining walls alongside each row of the new footings and back-fill alongside. This would divert surface drainage away from the footings and insulate them from the summer warmth. White tarpaulins could be placed over the girders and attached to these retaining walls to shade the footings. The enclosed spaces thus created could be cooled, if necessary, by drawing cold air from the base of the truss enclosure into these spaces with mine exhaust fans. Figure 4 is a sketch of the protection envisioned.

Figure 4. Retaining walls and a white fabric cover would be needed along the DYE-2 new footings to keep them cool and dry during the warm summer months.

A 210-ft sideways move of DYE-2, as was accomplished at DYE-3 in 1977, is also technically feasible. Because warmer conditions occur at DYE-2 during the summer months and rain occasionally occurs, some additional provisions will be necessary to prevent warming and meltwater undermining of the snow which supports the new footings (see Fig. 4). These provisions should not greatly add to the cost of a sideways move.
